# Public Interest Energy Research (PIER) Program FINAL PROJECT REPORT

# EFFICIENCY CHARACTERISTICS AND OPPORTUNITIES FOR NEW CALIFORNIA HOMES (ECO)

Prepared for: California Energy Commission Prepared by: Proctor Engineering Group, Ltd.

Contract Number: PIR-08-019

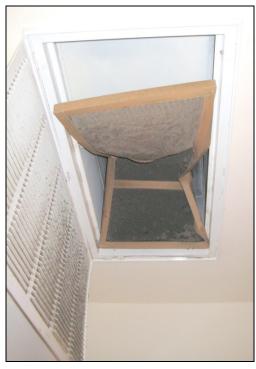
Figure 13: Unit 9—Dirty Filter

This 14 inch X 30 inch X 1 inch standard filter is so dirty it is sucked into the return duct that is substantially smaller than the return grille. The home owner is sufficiently embarrassed that he offers to go to the store and bring back a new filter. He is instructed specifically to bring back a low efficiency, low cost filter.

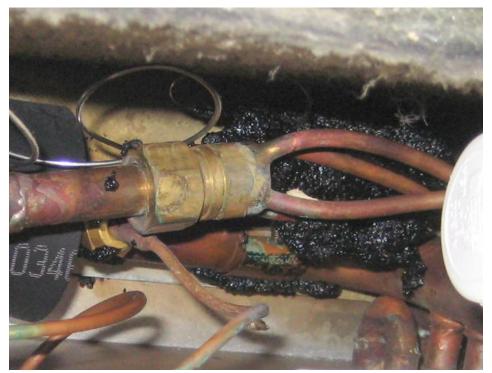
Figure 16: Unit 58—Melted TXV Bulb Insulation

• Unit 58 was borderline on the TXV superheat criterion (superheat was 24°F, Title 24 maximum is 25°F) and was undercharged in the first test. The unit was tested at 76°F ambient. Adding 43.5 oz. of refrigerant (31 percent of factory charge) brought the subcooling to within specification, but the superheat remained high at 26°F. The TXV had the temperature sensing bulb insulated to the cooling suction line. Since Unit 58 is a heat pump, the location is also the hot gas line in the heating mode. The temperature of the hot gas line in the heating mode exceeded the melting point of the insulation and the insulation dripped off, as shown in Figure 16.

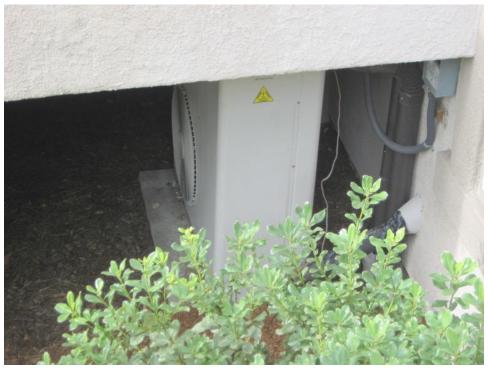
Figure 17: Unit 72—Condenser Recirculation

• Unit 72 failed the TXV maximum superheat criterion and was undercharged. The unit was tested at 75°F ambient temperature, but the location of the condensing unit caused recirculation (Figure 17) and a condenser air entering temperature of 103°F. Adding 87.5 oz. of refrigerant brought the unit to a subcooling of 10°F and changed the TXV superheat from 33°F to 4°F.

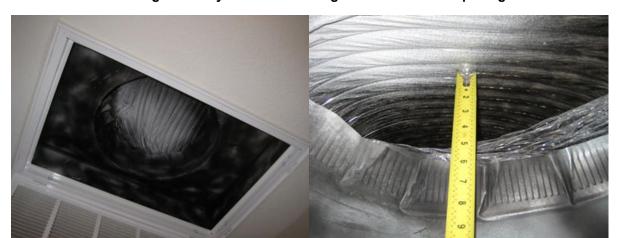
Figure 34: System 17—Existing Return With 5 in. Opening

- Unit had one 16 in. dia. return running 50 ft to a 20 in. x 30 in. filter grille in a distant hallway.
- The return duct took a sharp turn leaving the return grille so the actual duct was squashed to 5 in.
- The return was replaced with a new 20 in. x 30 in. filter grille in the hallway below the air conditioner feeding one 16 in. diameter duct and one 12 in. diameter duct into the blower compartment.

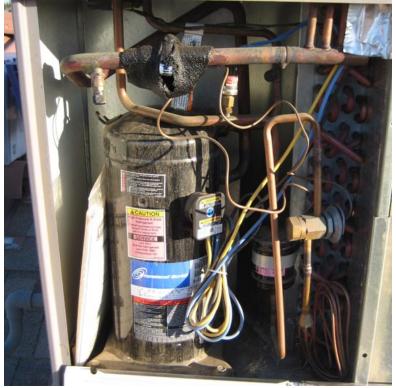
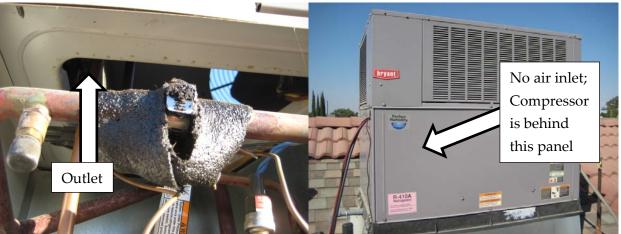
The system has no cooling inlet for the compressor and has melted the insulation on the TXV bulb (Figure 38 and Figure 39).

Figure 38: System 27—Compressor Compartment With Melted TXV Insulation

Figure 39: System 27—Compressor Heat Outlet With No Cooling Inlet

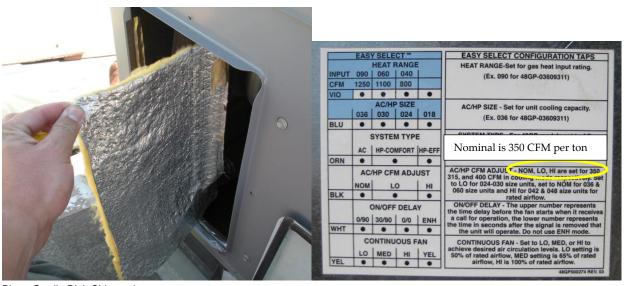
Figure 40: System 27—Rooftop Unit Cabinet Insulation and Fan Motor Setting Table

The insulation of this package rooftop unit is both thin and loose (Figure 40).

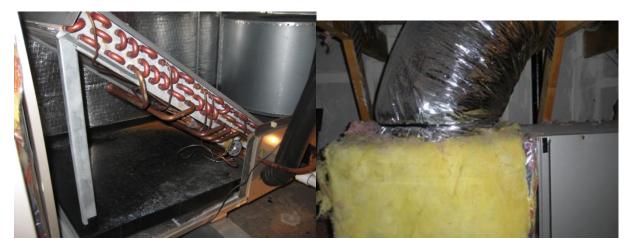
Figure 49: System 77—Slab Coil and Separate Side Feed Return Plenum

The return layout should have been straight into the "bottom" of the air handler.
