An Ounce of Prevention: Residential Cooling Repairs

Magazine Article
1991

Author:
John Proctor, P.E.

A Pacific Gas and Electric study of high cooling bill complaints in Fresno, California, revealed that low air conditioner efficiency could be remedied by informed diagnostic and repair techniques.

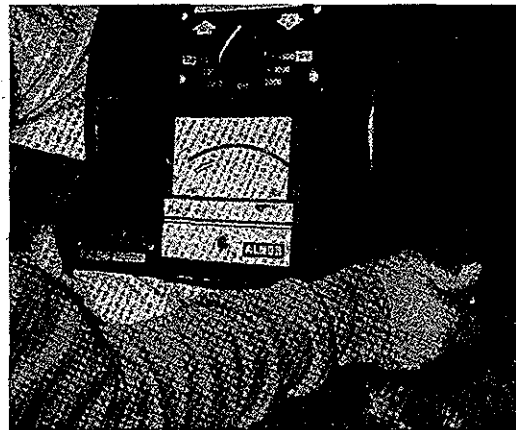
This flow hood placed over the return grill demonstrated a sizable air leakage reading due mainly to a faulty duct system.

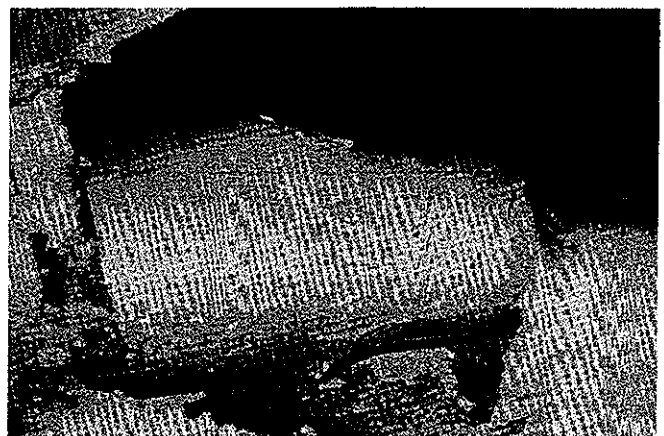
This gaping disconnection in the ductwork cancels out many of the benefits of an otherwise tightly built home.

The occupants of one house reported that one register didn't deliver any air. Our investigation showed that the ductwork was disconnected from that register and was stretched over toward a new register in an addition. The disconnected duct ended up not being attached to either register, dumping its conditioned air into the attic.

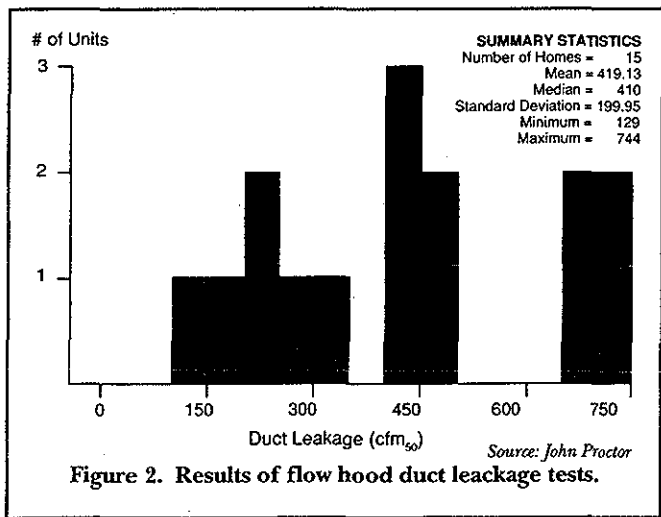
Figure 2. Results of flow hood duct leakage tests.

Duct leakage was the most prevalent energy waste problem, occurring in all but one of the homes studied. PEGrp and other researchers estimate that average leakage can be limited to 150 cfm at 50 Pa in existing housing stock. We found the average initial duct leakage in the houses in our study was 419 cfm (corrected to 50 pa pressure), more than twice the realizable level. Results of flow hood duct leakage tests are shown in Figure 2.

After an initial learning period during the Appliance Doctor Project, technicians were able to eliminate almost 60% of the measured duct leakage. With proper training and feedback, it's possible to spend four hours of work sealing ducts and achieve an average 65% reduction in leakage. Work by John Tooley in Florida produced an average reduction in duct leakage of 67%.⁴ Technicians do not normally conduct duct repairs; however, they could play a major role in reducing energy loss from this source.

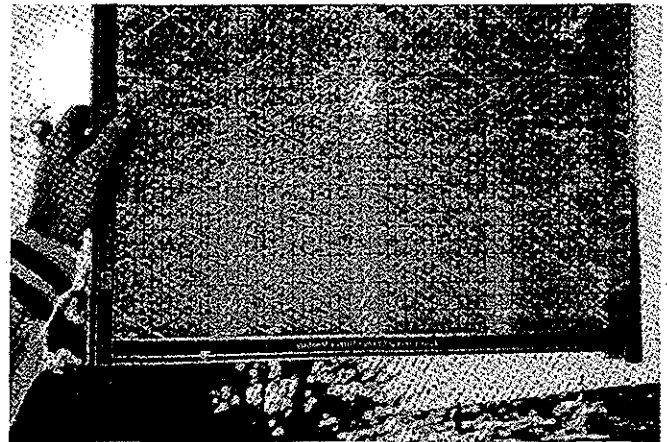
Other causes of low airflow include clogged filters and closed registers. At one study house, the filter had not been changed for over a year and only two of its ten delivery registers were fully open. Of the eight registers that were misadjusted, four were completely closed and four partially closed. Most air conditioning technicians do not regularly test for airflow. Indoor coils are often accessible only with extreme perseverance, decreasing the likelihood that they will be examined or cleaned. Crushed and kinked ducts, another cause of low airflow,

The sun can barely shine through the dirt build-up on this air filter. Replace those filters regularly!
