# Energy Design Update<sup>®</sup>

December 1986

## Research Shows Increased Building Tightness With Cellulose Insulation

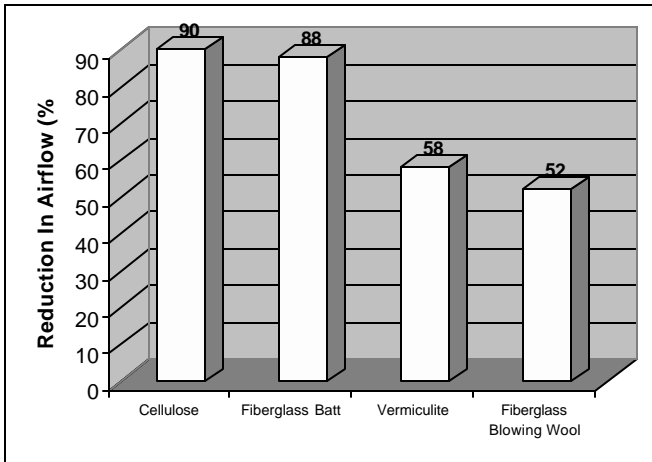
**Figure 2** – Percent air leakage reduction in test chamber with various types of insulation.  
 Source: Princeton University.

simulated attic floor consisting of a test platform with intentional cracks in it. Using a controlled pressure device, air was forced through the cracks in the platform, first with no insulation on it, then successively with cellulose, fiberglass batts, fiberglass blowing wool, and finally vermiculite on it. The relative reduction in airflow caused by the various materials was measured. The results are shown in figure 2. The greatest reduction was caused by cellulose insulation.

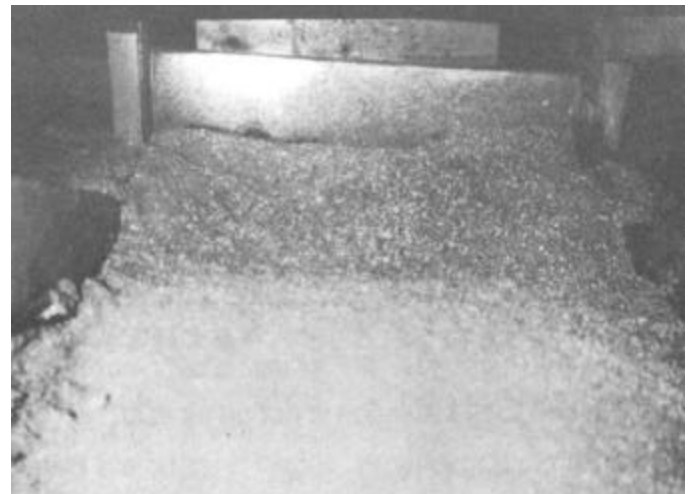
Figure 4 shows a section of attic insulated with cellulose. The installation looks pretty good, but if you look closely you will see that the cellulose has settled in the area over the soffit at the top of the photograph. The cause of the settling was wetness. Also, water stains can be seen on the wood framing.

**Figure 4** – Attic insulated with cellulose. Settling over soffit was caused by insulation being wetted by moist air leakage through attic floor.

Blower door tests of this house showed it to be reasonably tight (about 3.4 air changes per hour at 50 Pa) and the cellulose insulation was probably responsible for a certain degree of that tightness. However, the defects illustrated in Figures 4 through 7 suggest that even though the insulation may suppress air leakage, it is not effective enough to serve as a good air barrier.

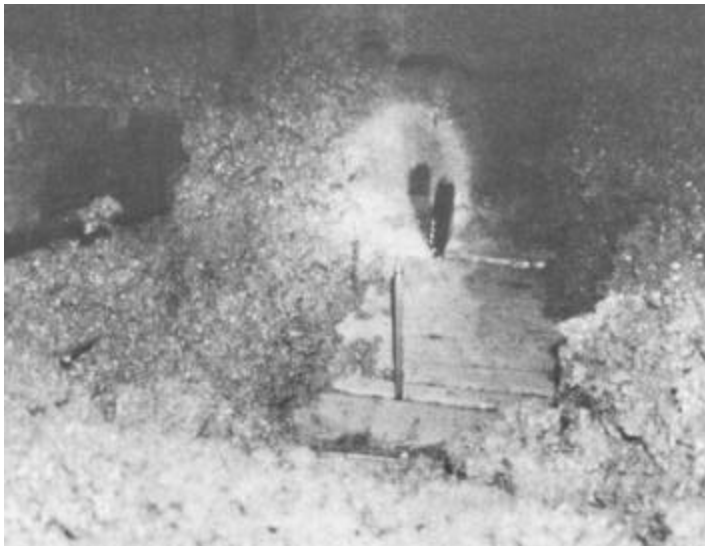
Figure 5 shows the same area with some of the cellulose removed. The pencil in the photograph is sticking in a gap between a 2 x 4 and a piece of plywood. The pocket knife is shown sticking into a gap between the plywood and the top plate of the exterior wall. There was apparently no attempt to seal these gaps and moisture laden air was evidently leaking up into the attic from the space below.

**Figure 5** – Attic floor showing points of air leakage.

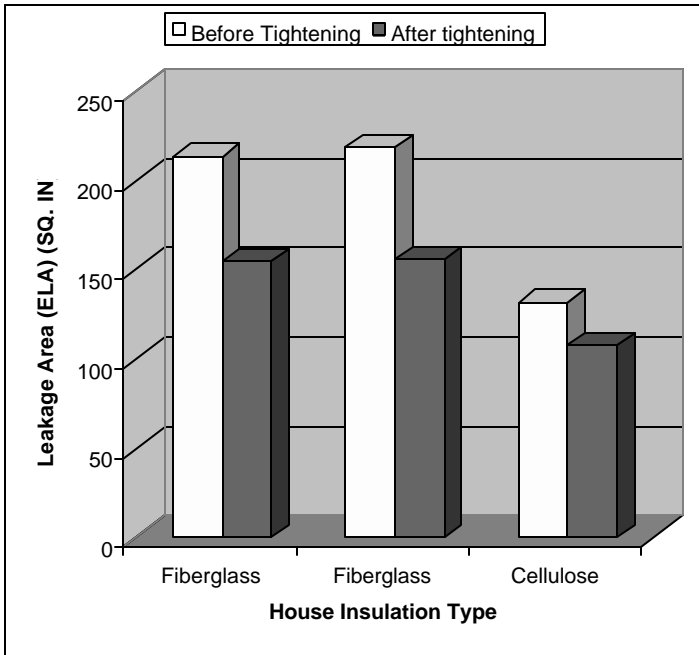
The three buildings were pressure tested with a blower door at the completion of construction. Some air sealing work was then done and the buildings were retested. Figure 8 shows the results of the tests. The effective leakage area (ELA) of the building with cellulose was 40% lower than the average ELA of the two buildings with fiberglass before the air sealing work and 27% below the fiberglass buildings after the air sealing work.

**Figure 8** – Comparison of measured air leakage of buildings insulated with fiberglass and buildings insulated with cellulose.
