# Public Interest Energy Research (PIER) Program FINAL PROJECT REPORT

# EFFICIENCY CHARACTERISTICS AND OPPORTUNITIES FOR NEW CALIFORNIA HOMES (ECO)

Prepared for: California Energy Commission Prepared by: Proctor Engineering Group, Ltd.

Contract Number: PIR-08-019

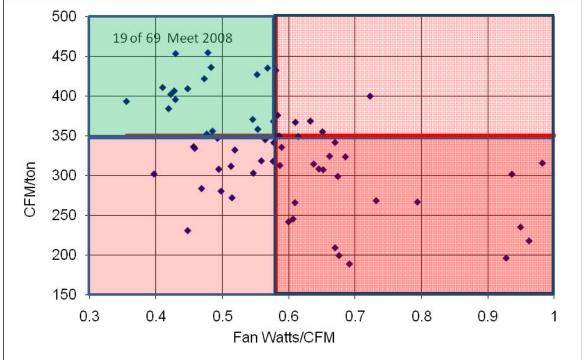
Figure 9: Cooling Airflow and Fan Power

Title 24–2008 provides a prescriptive standard for cooling airflow and fan power. Figure 9 shows that only 19 of 69 systems tested (28 percent) meet this standard. Potential causes of the failure to meet this standard are discussed in the Air Distribution section.

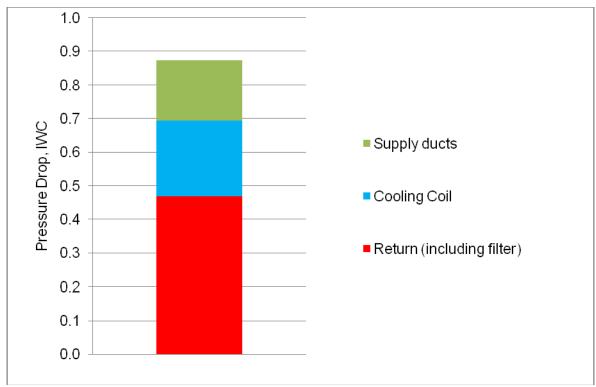
Figure 10: Cooling Airflow Average External Static Pressure

One cause of the low airflows and high watt draws per CFM is the restrictive nature of these duct systems. The average return system pressure drop (including filter), coil pressure drop, and supply pressure drops are shown in Figure 10. Notice that the average return system alone is almost equal to the nameplate certified maximum TOTAL cooling static pressure of 0.50 IWC for all but three of the air conditioners.

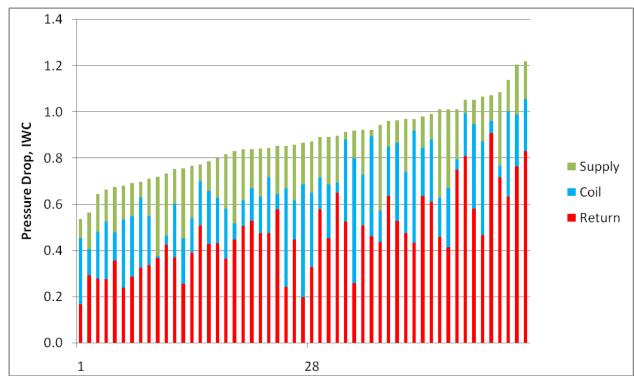
Figure 11: Cooling Airflow External Static Pressure by Component

Figure 11 shows the pressure drops in the return, evaporator coil, and supply duct system arranged from the least restrictive system to the most restrictive system. The dominant influence of the return flow resistance is evident in this graph.

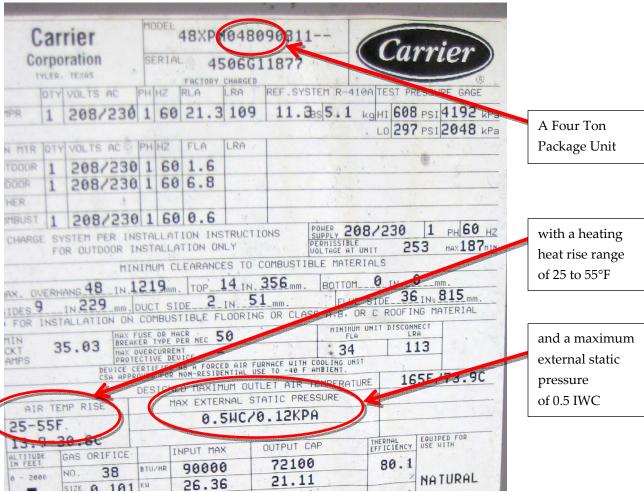
Figure 12: Unit 9—HVAC Label

The high filter pressure drops are due to a combination of inadequate filter size and the widespread use of 1 inch pleated filters that have high pressure drops even when new. Unit 9 provides an example of the problem, as illustrated by Figure 12 through Figure 14.

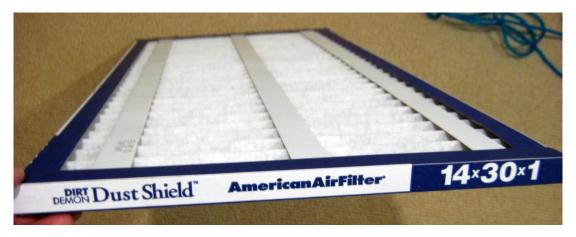
Figure 14: Unit 9—Replacement Filter Purchased by Homeowner

The home owner returns with a 14" X 30" X 1" pleated filter. He is pleased because: "This is 16 times better!"

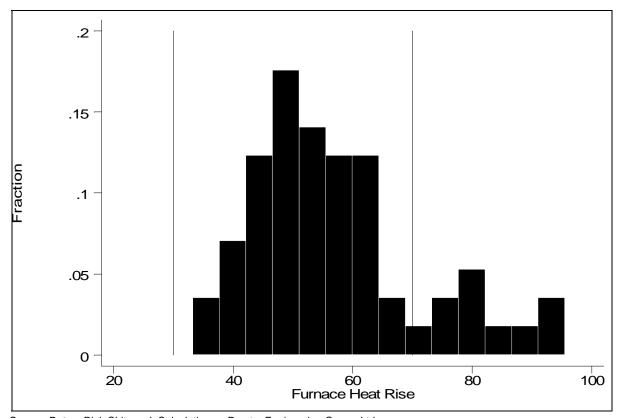
Figure 18: Calculated Furnace Heat Rise

Based on a steady state efficiency of .85, the heat rise ranges between 34°F and 96°F, as shown in Figure 18.³Approximately 20 percent of the units exceed the manufacturer's certified heat rise; substantially more of the units exceed their optimum heat rise. Higher heat rises reduce the efficiency of the units below their AFUE rating.

With proper airflow the data would range from 30°F to 70°F and be a normal distribution centered at about 50°F. This data is skewed to the right (high heat rise due to low airflow). Low airflow not only lowers the efficiency of the furnace, it can also cause the unit to cycle the gas off and on by the limit switch, potentially increasing heat exchanger fatigue and corrosion.

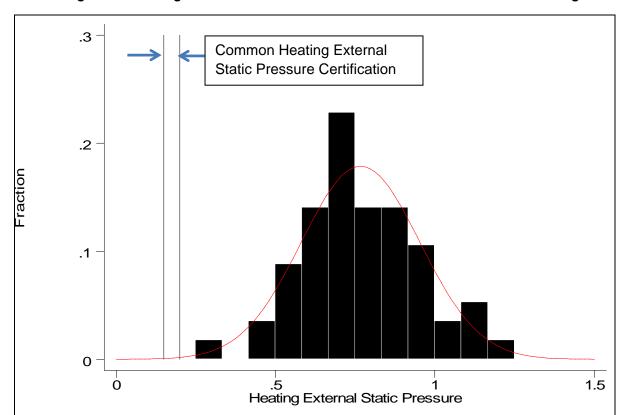
Figure 19: Heating Mode External Static Pressure vs. Common Certification Range

The cause of the low airflow is a combination of unrealistically low heating static pressure certifications (generally between 0.15 Inches of Water Column and 0.25 Inches of Water Column) and the true external static pressures displayed in Figure 19.

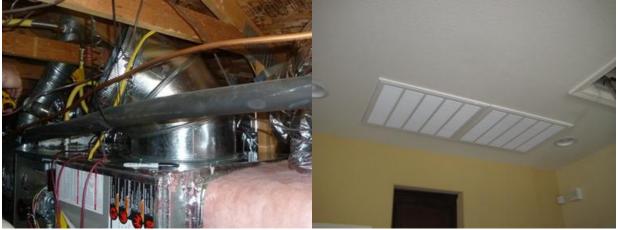
Figure 36: System 25—Metal Elbow Into Cabinet and New Filter Grille

This change lowered the return static pressure from 0.39 IWC to 0.10 IWC and increased flow 11 percent. The Normalized Sensible EER increased by 8 percent.

• Added a 20 in. x 25 in. filter grille next to existing 20 in. x 25 in. filter grille and ducted via a 14 in. R-8 duct into furnace cabinet with a metal elbow at the motor side of the blower cabinet (see Figure 36).
