An Ounce of Prevention: Residential Cooling Repairs

Magazine Article
1991

Author:
John Proctor, P.E.

A Pacific Gas and Electric study of high cooling bill complaints in Fresno, California, revealed that low air conditioner efficiency could be remedied by informed diagnostic and repair techniques.

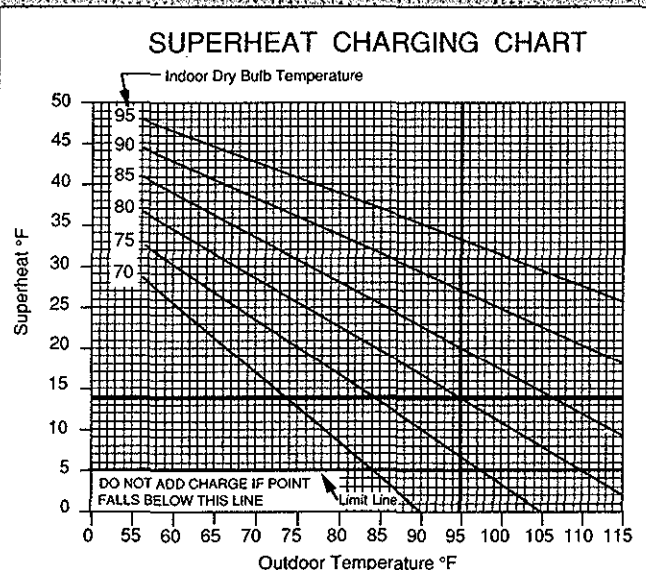
Suction Line Temperature	59°F
Cold Coil Saturation Temperature	42°F
Actual Superheat (59°F minus 42°F)	17°F
Outdoor Dry-Bulb Temperature	95°F
Indoor Dry-Bulb Temperature	80°F
From Figure 2, Correct Superheat	14°F

Since the actual superheat is within 5°F of the correct superheat from the chart, the unit is charged properly. Adjusting the charge should be attempted only by thoroughly trained individuals.

Chart based on 400cfm/ton indoor airflow and 50% relative humidity.
