Prepared by:  
Proctor Engineering Group, Ltd.  
San Rafael, CA 94901  
(415) 451-2480

**Persistence #3A:  
AN ASSESSMENT OF TECHNICAL  
DEGRADATION FACTORS:  
COMMERCIAL AIR CONDITIONERS AND  
ENERGY MANAGEMENT SYSTEMS**

Submitted To:  
CADMAC Persistence Subcommittee  
Pacific Gas and Electric  
San Diego Gas & Electric  
Southern California Edison  
Southern California Gas  
CADMAC Report # 2028P

**Final Report**  
February 25, 1999

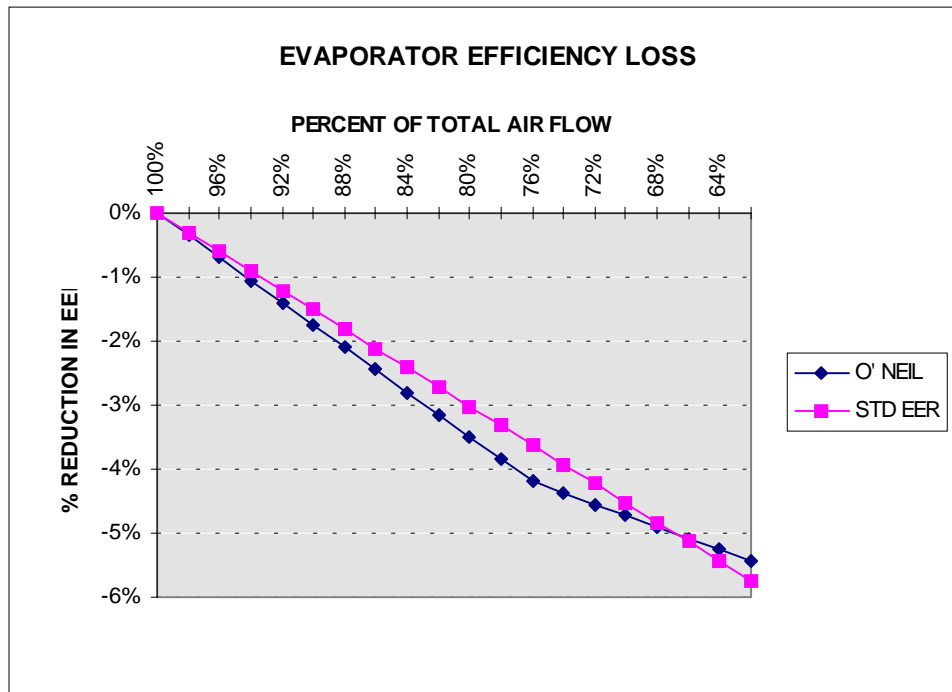
**Figure 3-1 Change in efficiency with reduction in air flow**

Fouling of the evaporator coils did not produce a significant deterioration in the performance for either the standard or high efficiency coils. The performance of the fouled coils correlates well with test data on the performance of systems under reduced air flows (O'Neil, et al, 1996). Test results for standard efficiency coils, and the reference test data, are shown in Figure 3-1.

Figure 3-1. depicts the change in performance (EER) as a function of the loss in air flow.

Additional tests were run on the system to determine if the reduction in air flow was due to fouling of the coils or fouling of the blower. The tests showed that the vast majority of the air flow reduction occurred at the coil and not the blower.

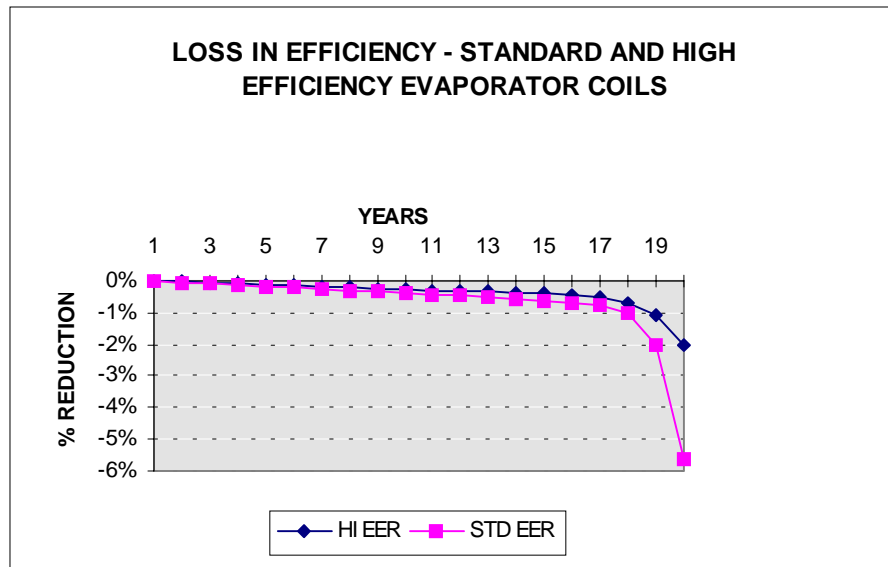
Figure 3-2 - Evaporator coil test results

The comparison between the high efficiency coils and the standard coils are shown in Figure 3-2.

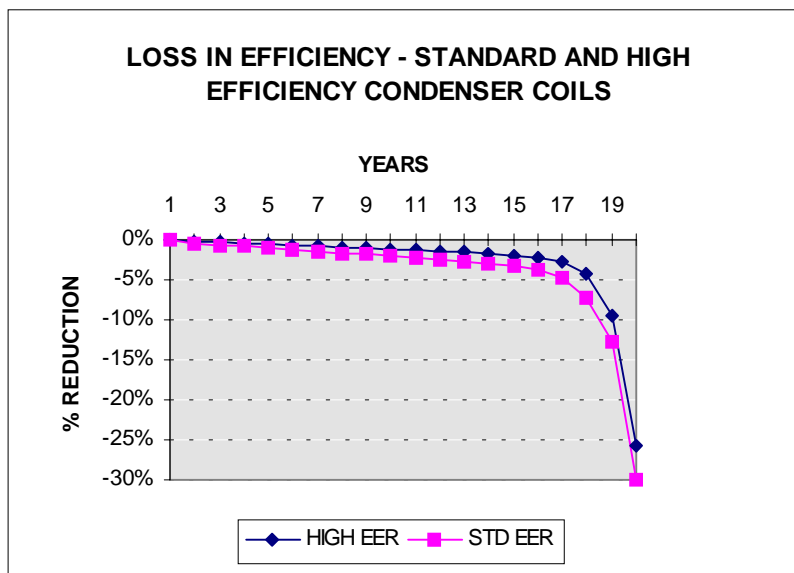
Figure 3-3 - Condenser coil test results

Tests on the condenser coils demonstrated that the performance of the units was reasonably unaffected by loss of air flow. The combination of evaporator and condenser fouling resulted in the loss of performance due to flood-back of refrigerant to the compressor. As predicted, the efficiency and energy use dropped due to fouling of the evaporator and the efficiency dropped while the energy use increased by fouling the condenser.

The standard efficiency and high efficiency condenser coils have similar fouling characteristics. The high efficiency unit was able to maintain a higher overall efficiency and thus have a longer life expectancy and operating efficiency. Figure 3-3 shows the results of the testing.

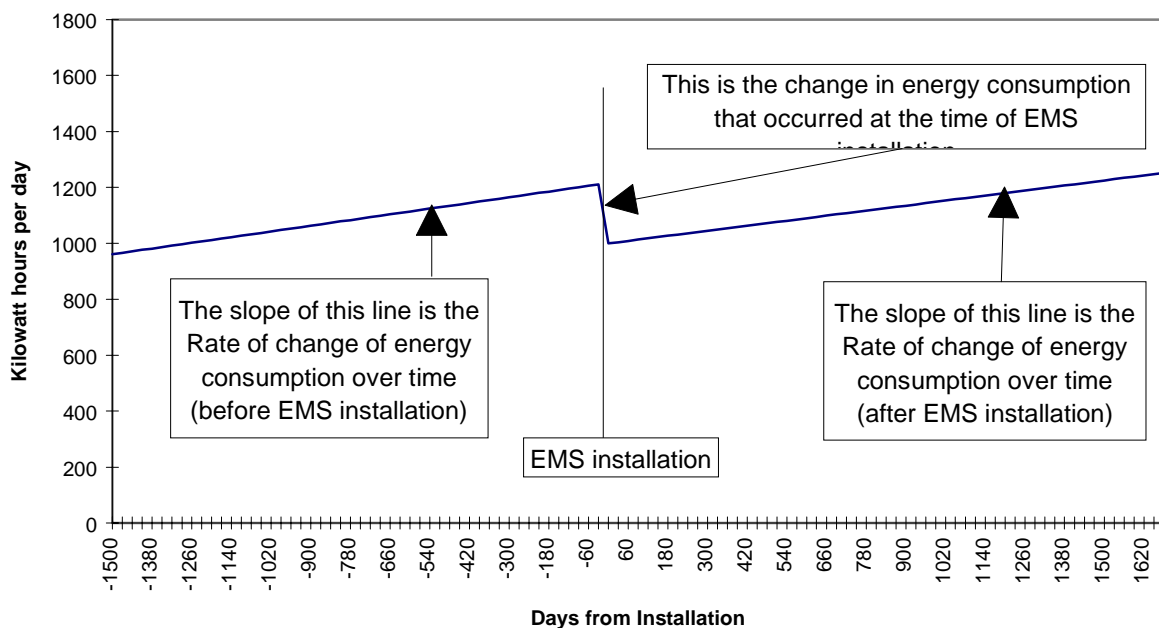
**Figure 5-1 Conceptual Model: Energy Consumption vs. Days from EMS Installation**

A basic model was developed with consists of three primary components: the change in energy consumption at the time of the installation of the EMS (kwh/day), the rate of energy consumption change over the long term (kwh/day per day), and how this rate of energy consumption change is effected by the installation of the EMS system. This basic conceptual model is shown in Figure 5-1.

This model allows there to be a long term change in load, a change in the energy consumption at the time of the EMS installation (initial savings), and a new load change rate. If the pre installation rate grows less than the post installation rate, there is degradation of savings. If the pre installation rate grows more than the post installation rate, there is an increase in savings.

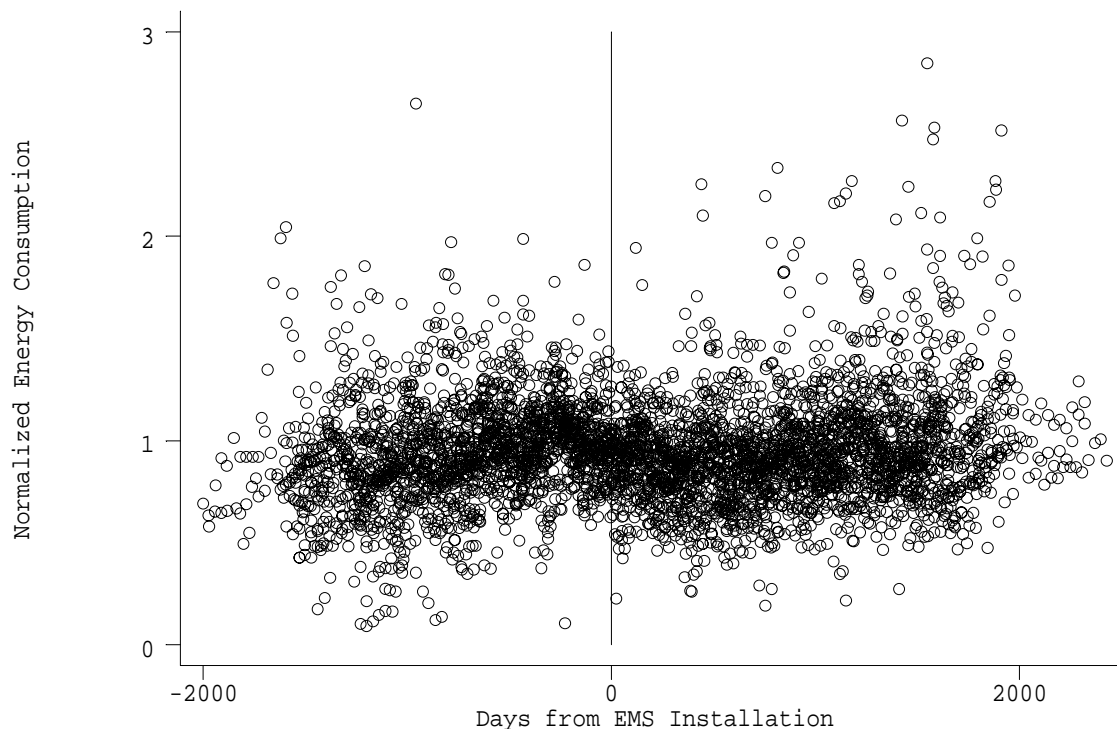
**Figure 5-2 Normalized Energy Consumption vs. Days from EMS Installation**

The NEC for all units for all billing periods is shown in Figure 5-2.

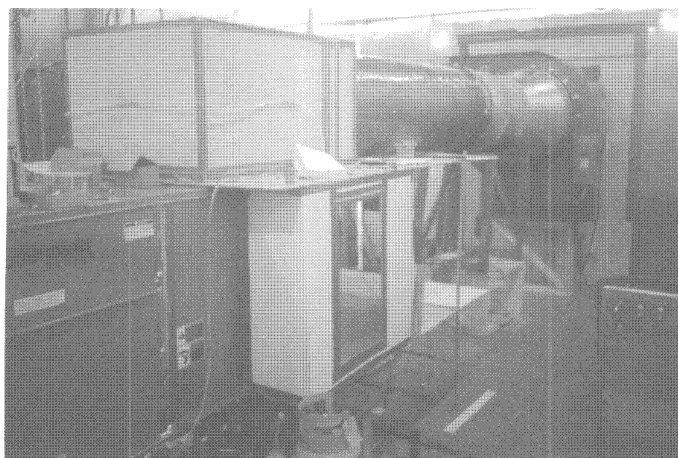
**FIGURE A-4 CONDENSER MODIFICATIONS**

The condenser side of the air conditioning unit was outfitted with specially designed air flow devices. The standard louvered panels on the inlet side of the coil were replaced with a directional enclosure. This design allows access to the entire coil while providing a single location for the input of contaminants. A collection hood was built for the exhaust side of the condenser. The hood was connected to a filter bank and the air flow measurement fan. The fan system was used to offset the pressures created by the modifications. Plexiglas panels were installed around the coil to allow for observation of the fouling process.

Figure A-4 shows the condenser side of the air conditioning unit.

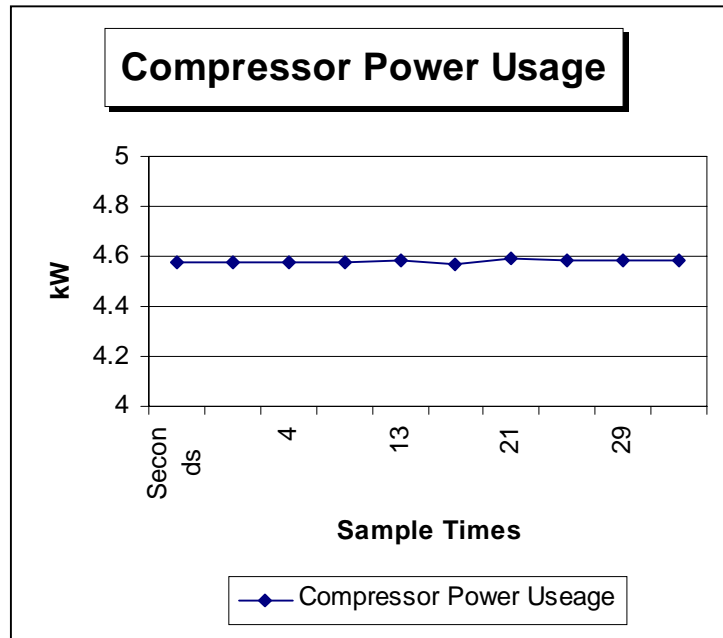
**Figure C-1 Compressor Power Usage - Test # CHECK30**

Each of the data files contain the 8-10 readings on every channel. This includes those that were used to calculate the average performance of the unit over that sampling period. The sample readings are typically 4 seconds apart. Figure C-1. shows a sample plot of the compressor power usage for test CHECK30.

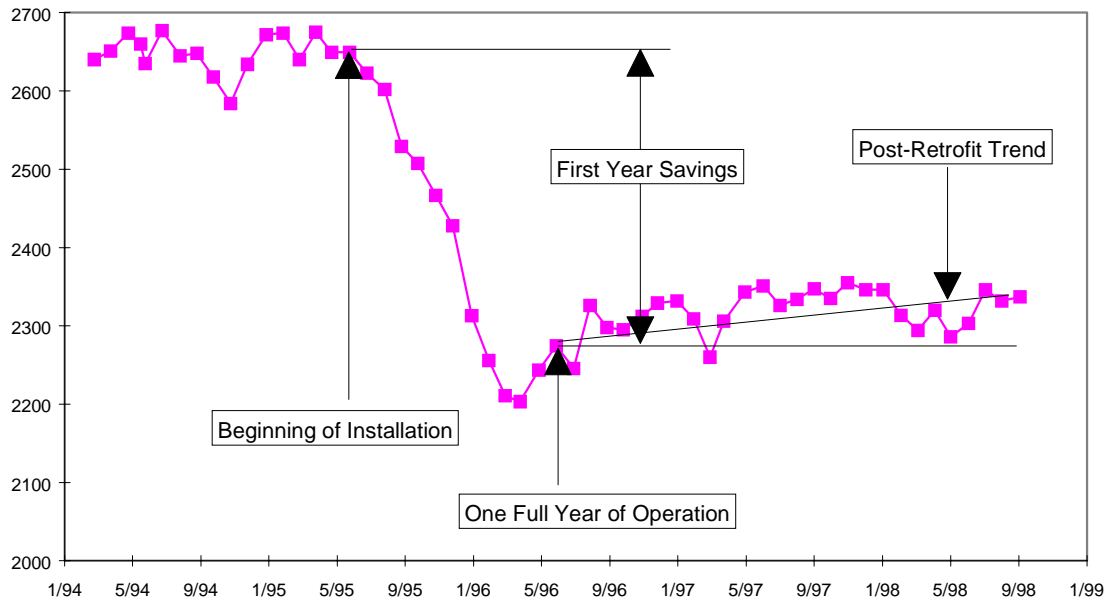
**Figure G-1 Illustration of Moving Average Analysis**

The simplest case of this model is illustrated in Figure G-1.

Each point in this figure is the running 12 month average of electrical consumption (kWh per day). In the case illustrated in Figure G-1 the trend in electrical consumption before the EMS installation is level. The time of the installation is clear because of the inflection point. The full first year savings are shown after 12 months when there are no pre-installation months in the moving average. The degradation rate is within the post-retrofit trend (growth in load) after the first year.

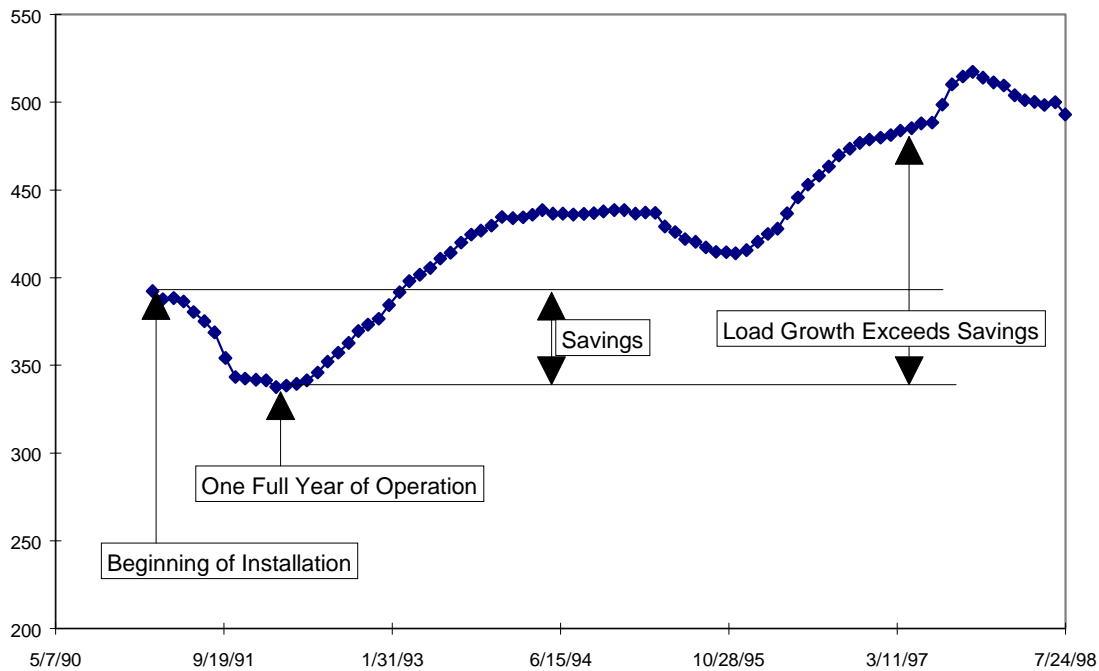
**Figure G-2 PG&E 6.2**

The load growth far exceeded the savings. This is an example of the fact that load growth is not necessarily degradation of the EMS system. This is illustrated in Figure G-2.

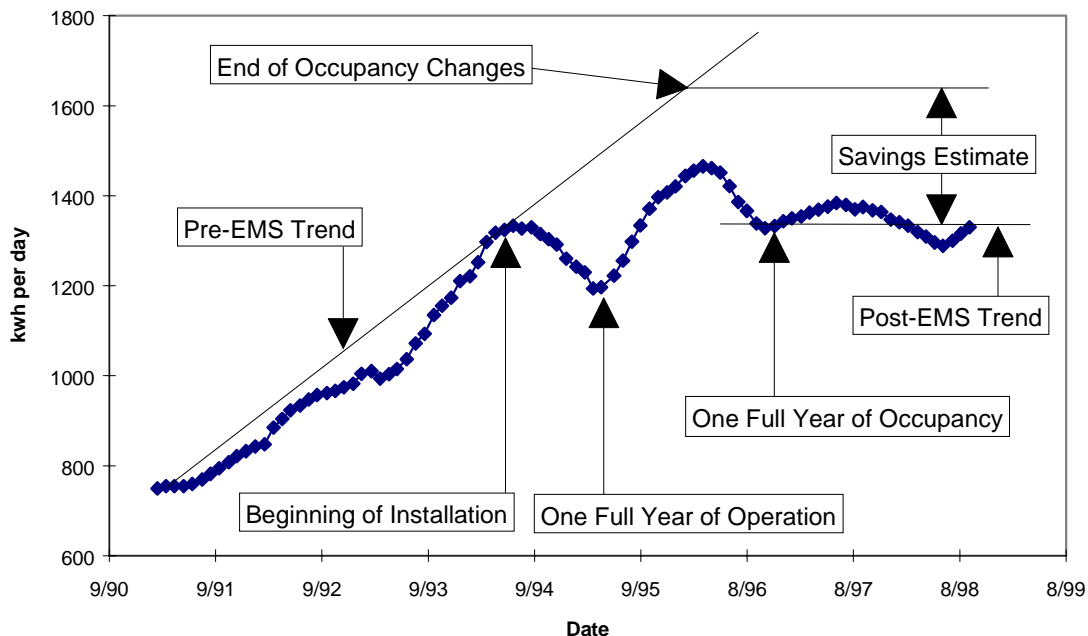
Figure G-3 PG&E 7.1

This unit is an office building. Load growth is evident both before and after the EMS is installed. The occupancy in this building increased up to January of 1996. At that time a new owner took over the building. When the new owner took over the building the new managers started investigated the operation of the EMS system and put it into full use. The moving average (ma) analysis was used to estimate savings based on stable occupancy beginning January 1996. This is illustrated in Figure G-3. The time series analyses produced different results because they projected pre-EMS growth trends without end.

The ma analysis produced the best estimates of savings and persistence. The pre-EMS load increased at 187 kWh per day per year. The post-EMS load growth is projected to be nil. The savings are a constant 304 kWh per day.

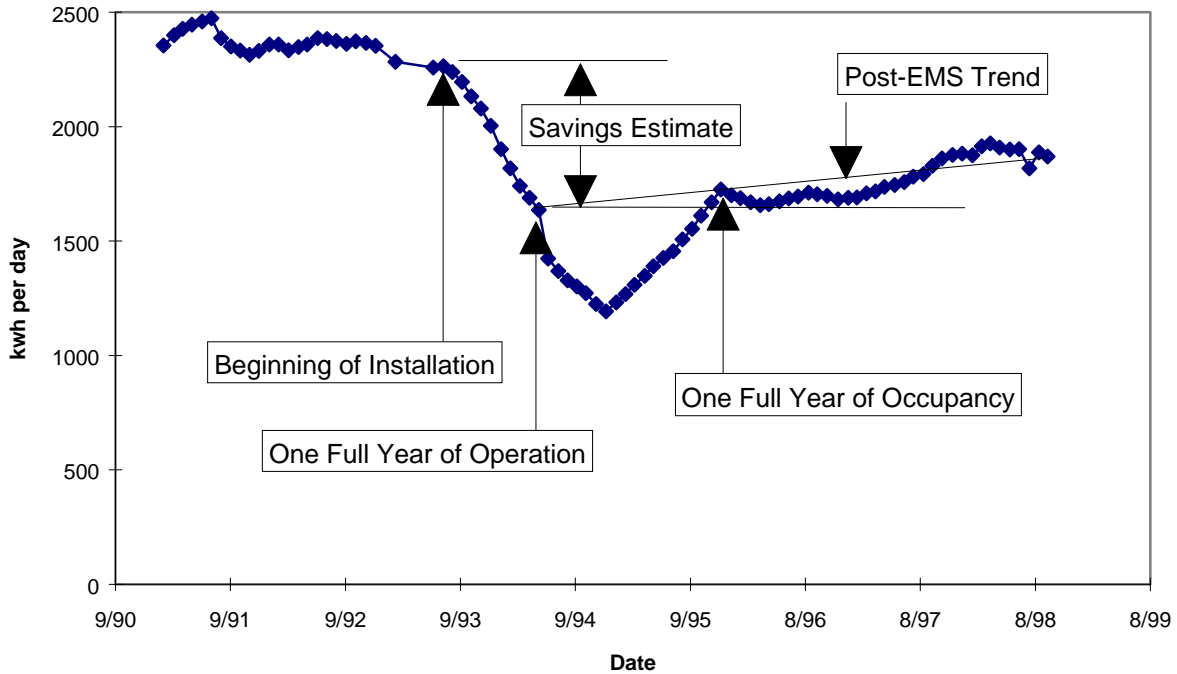
**Figure G-4 SCE 4.6**

The ma analysis for this unit is demonstrated by Figure G-4

This unit is an office building. It had a major occupancy change in the same time period as the EMS installation. Energy consumption had been nearly stable for a number of years prior to the EMS installation. After EMS installation the occupancy fell. The occupancy has returned to full. The moving average (ma) analysis was used to estimate savings and consumption growth. The other time series analyses produced very high estimates of savings. The pre-EMS load trend is taken as 0. The post-EMS load increased at 53 kWh per day per year. The net load increase was 53 kWh per day per year. The savings was 623 kWh per day.
